Debris/Ice/TPS Assessment And Photographic Analysis For Shuttle Mission STS-33R

Charles G. Stevenson
NASA/Kennedy Space Center

DEBRIS/ICE/TPS ASSESSMENT
AND
PHOTOGRAPHIC ANALYSIS
OF
SHUTTLE MISSION STS-33R

November 22, 1989

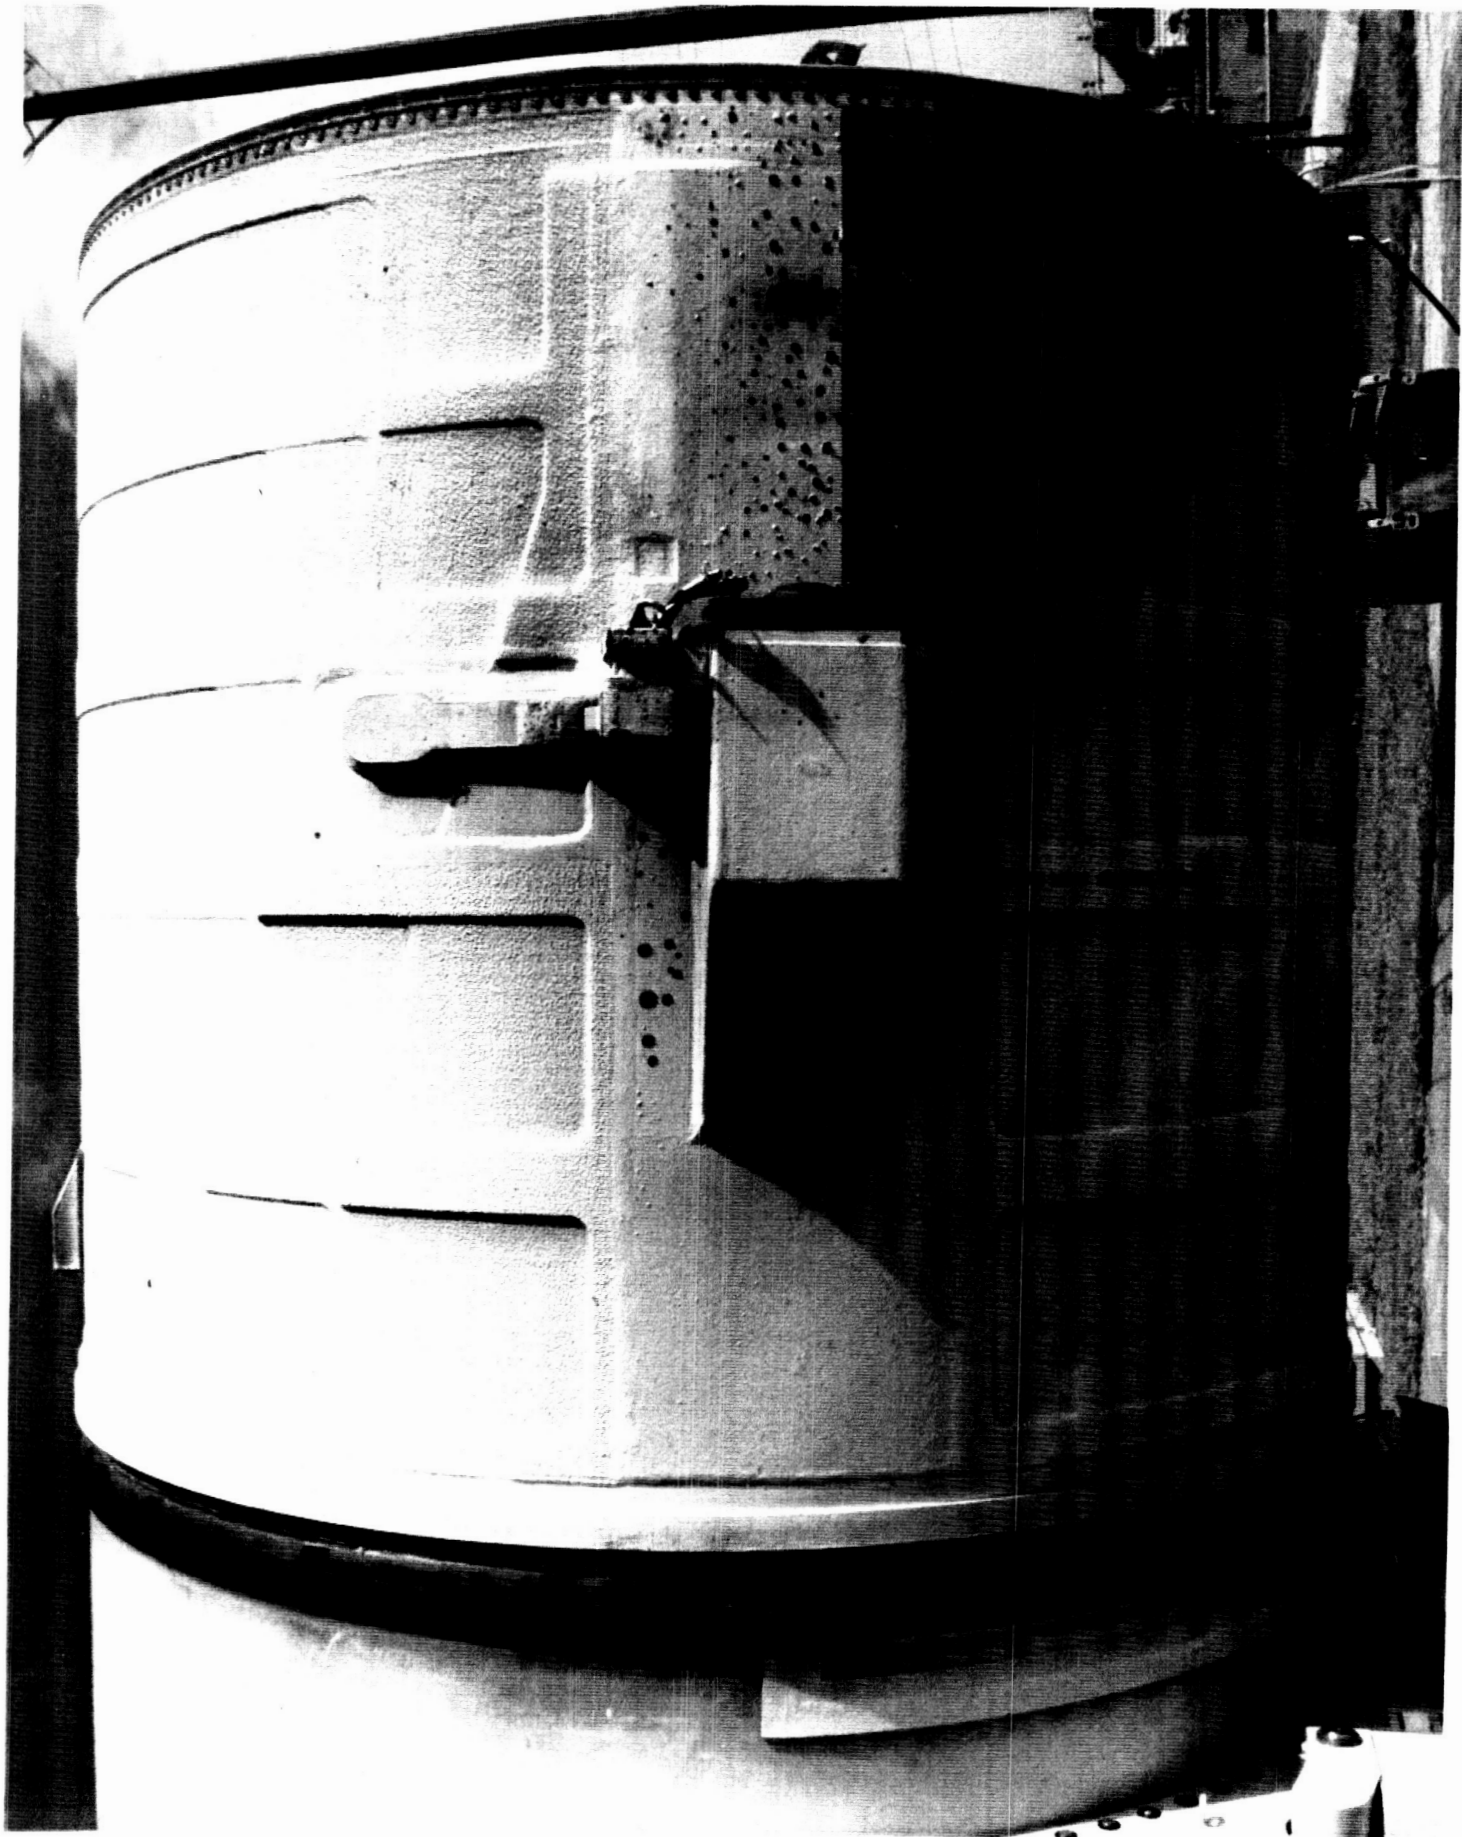
Overall view of the SRB forward skirt shows blistering of the
Hypalon paint with attached (delaminated) layers of MSA

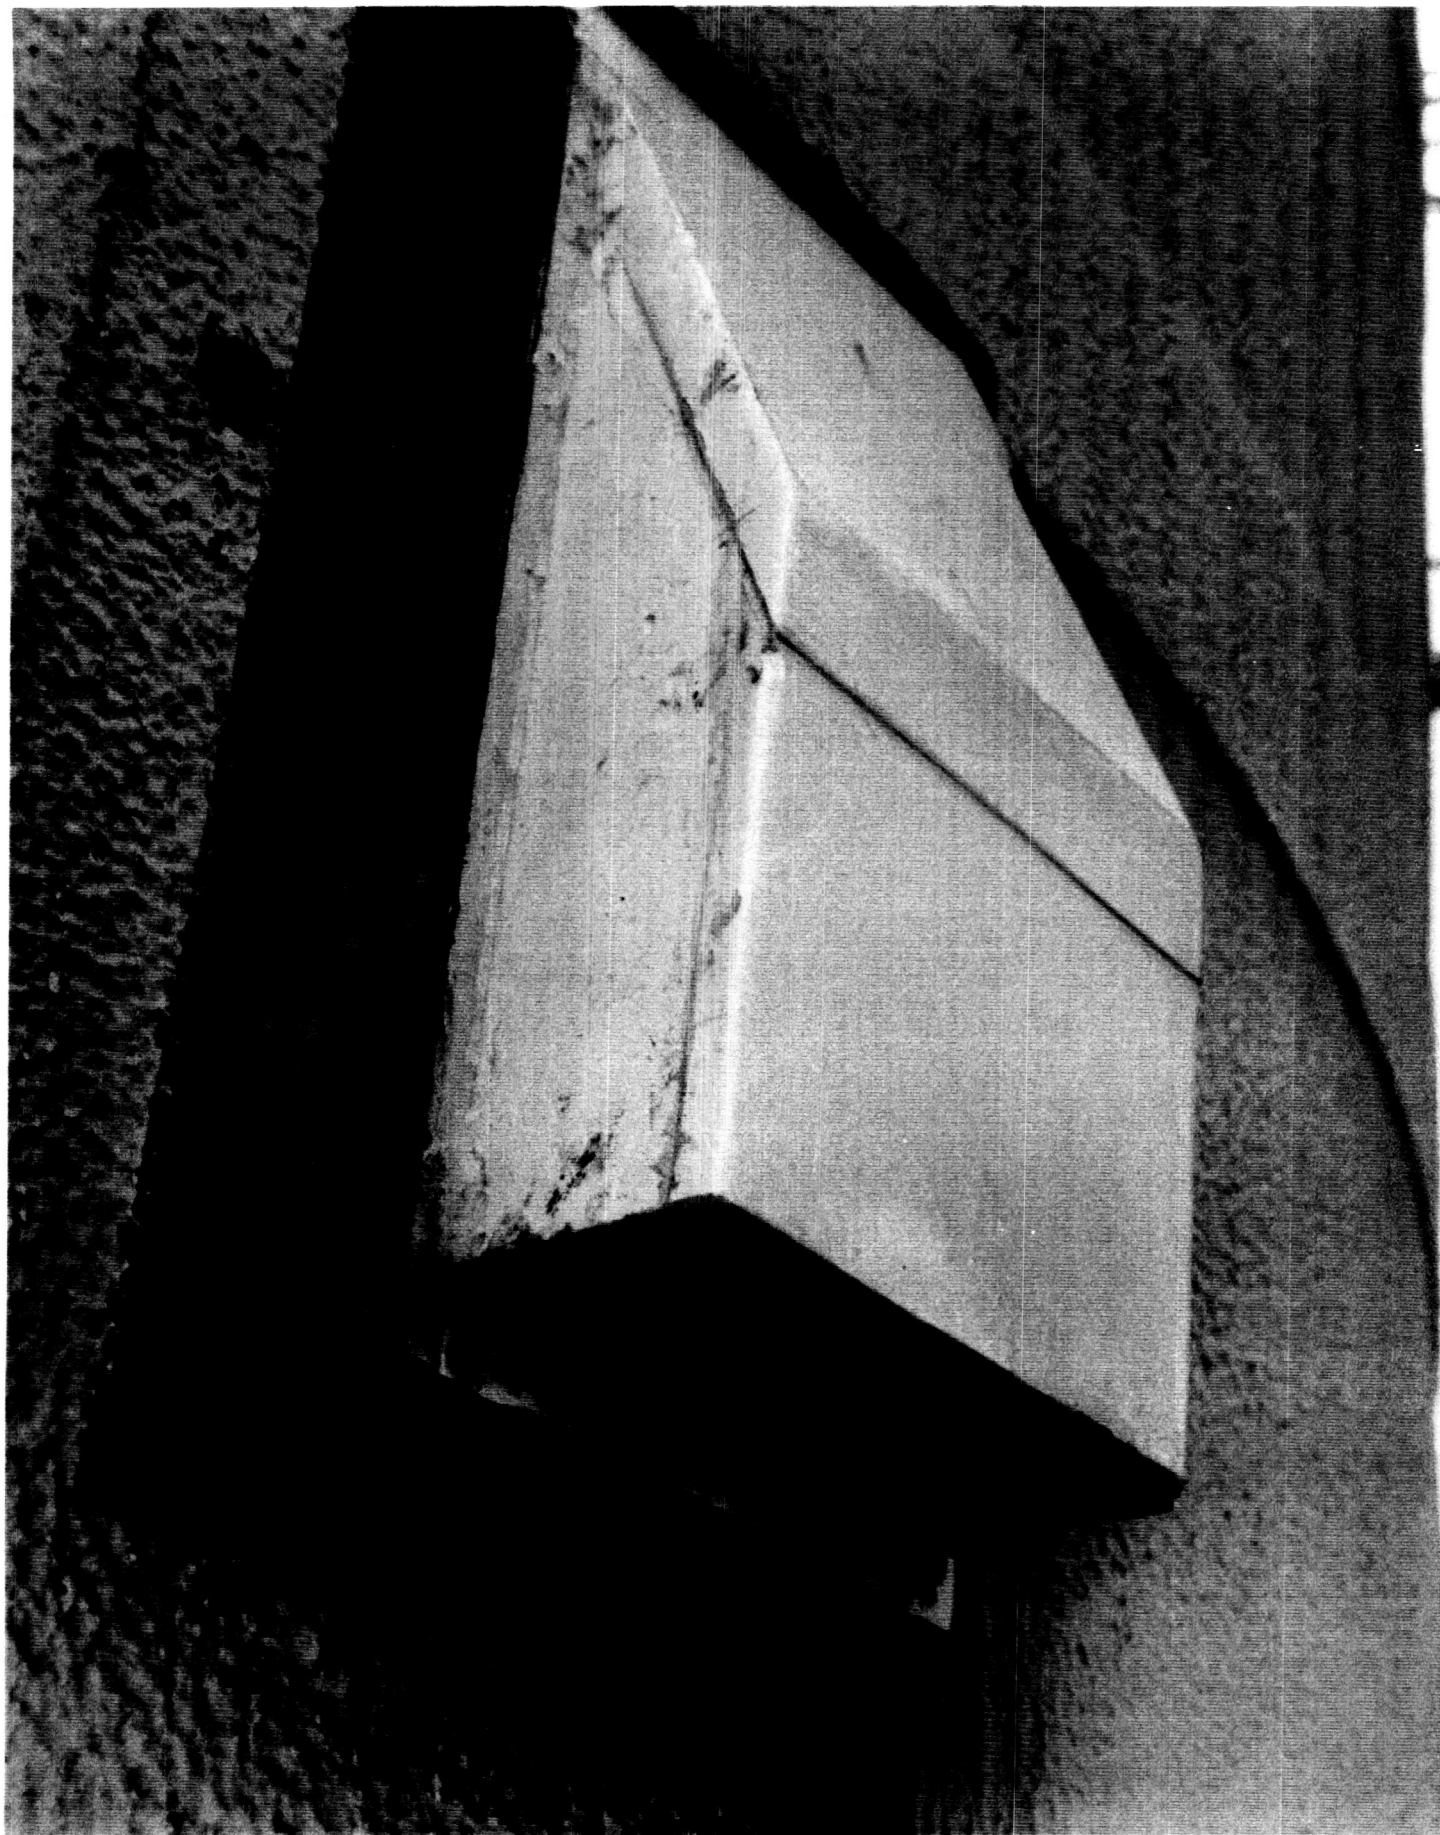
The phenolic plate on the RSS antenna was delaminated
and some material was missing

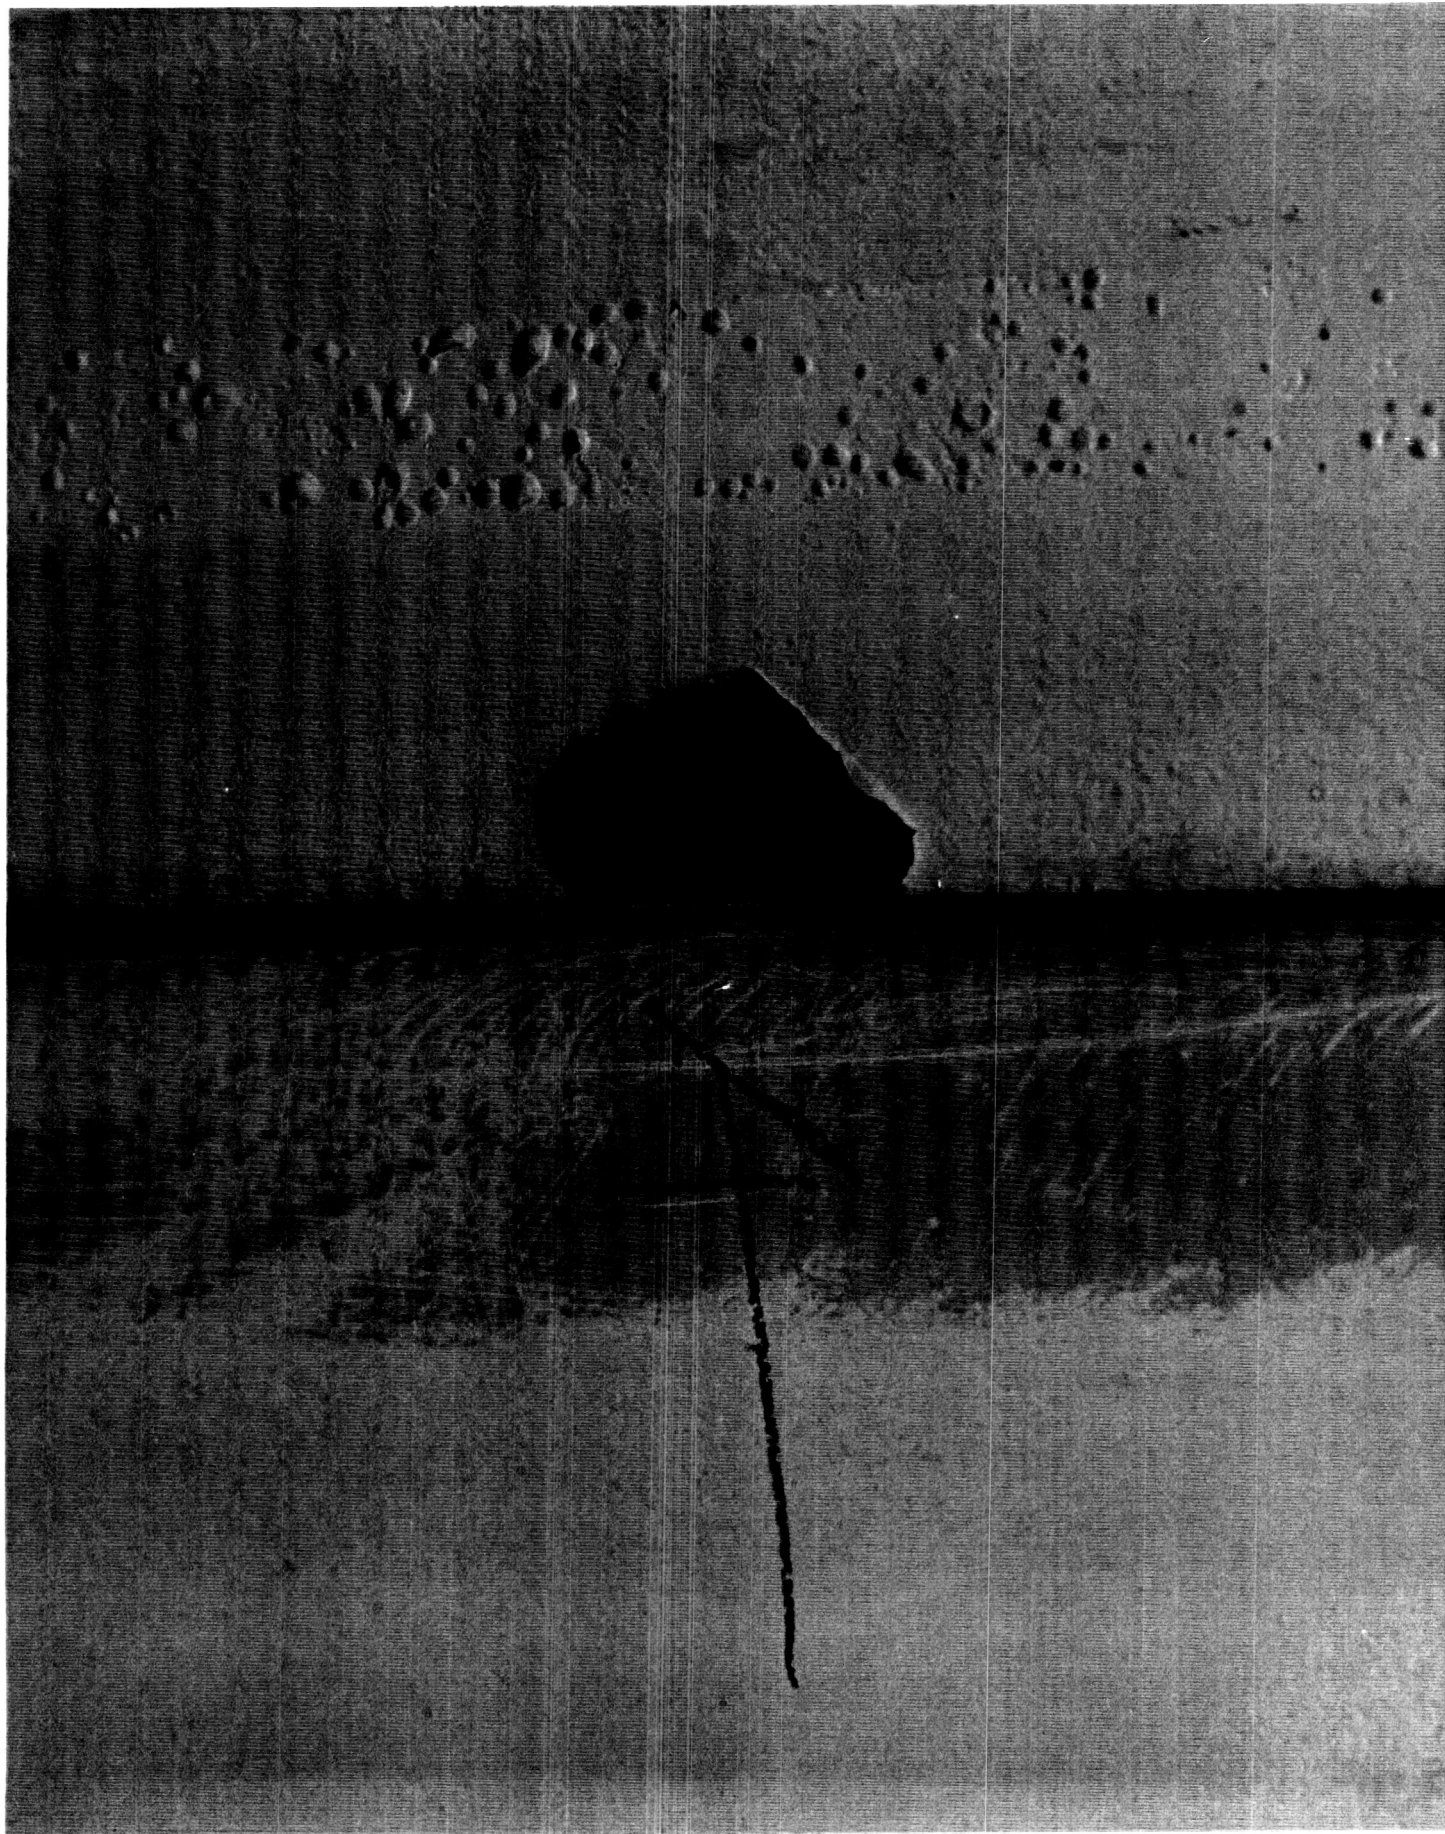
Divot in cork closeout material showed sooted substrate

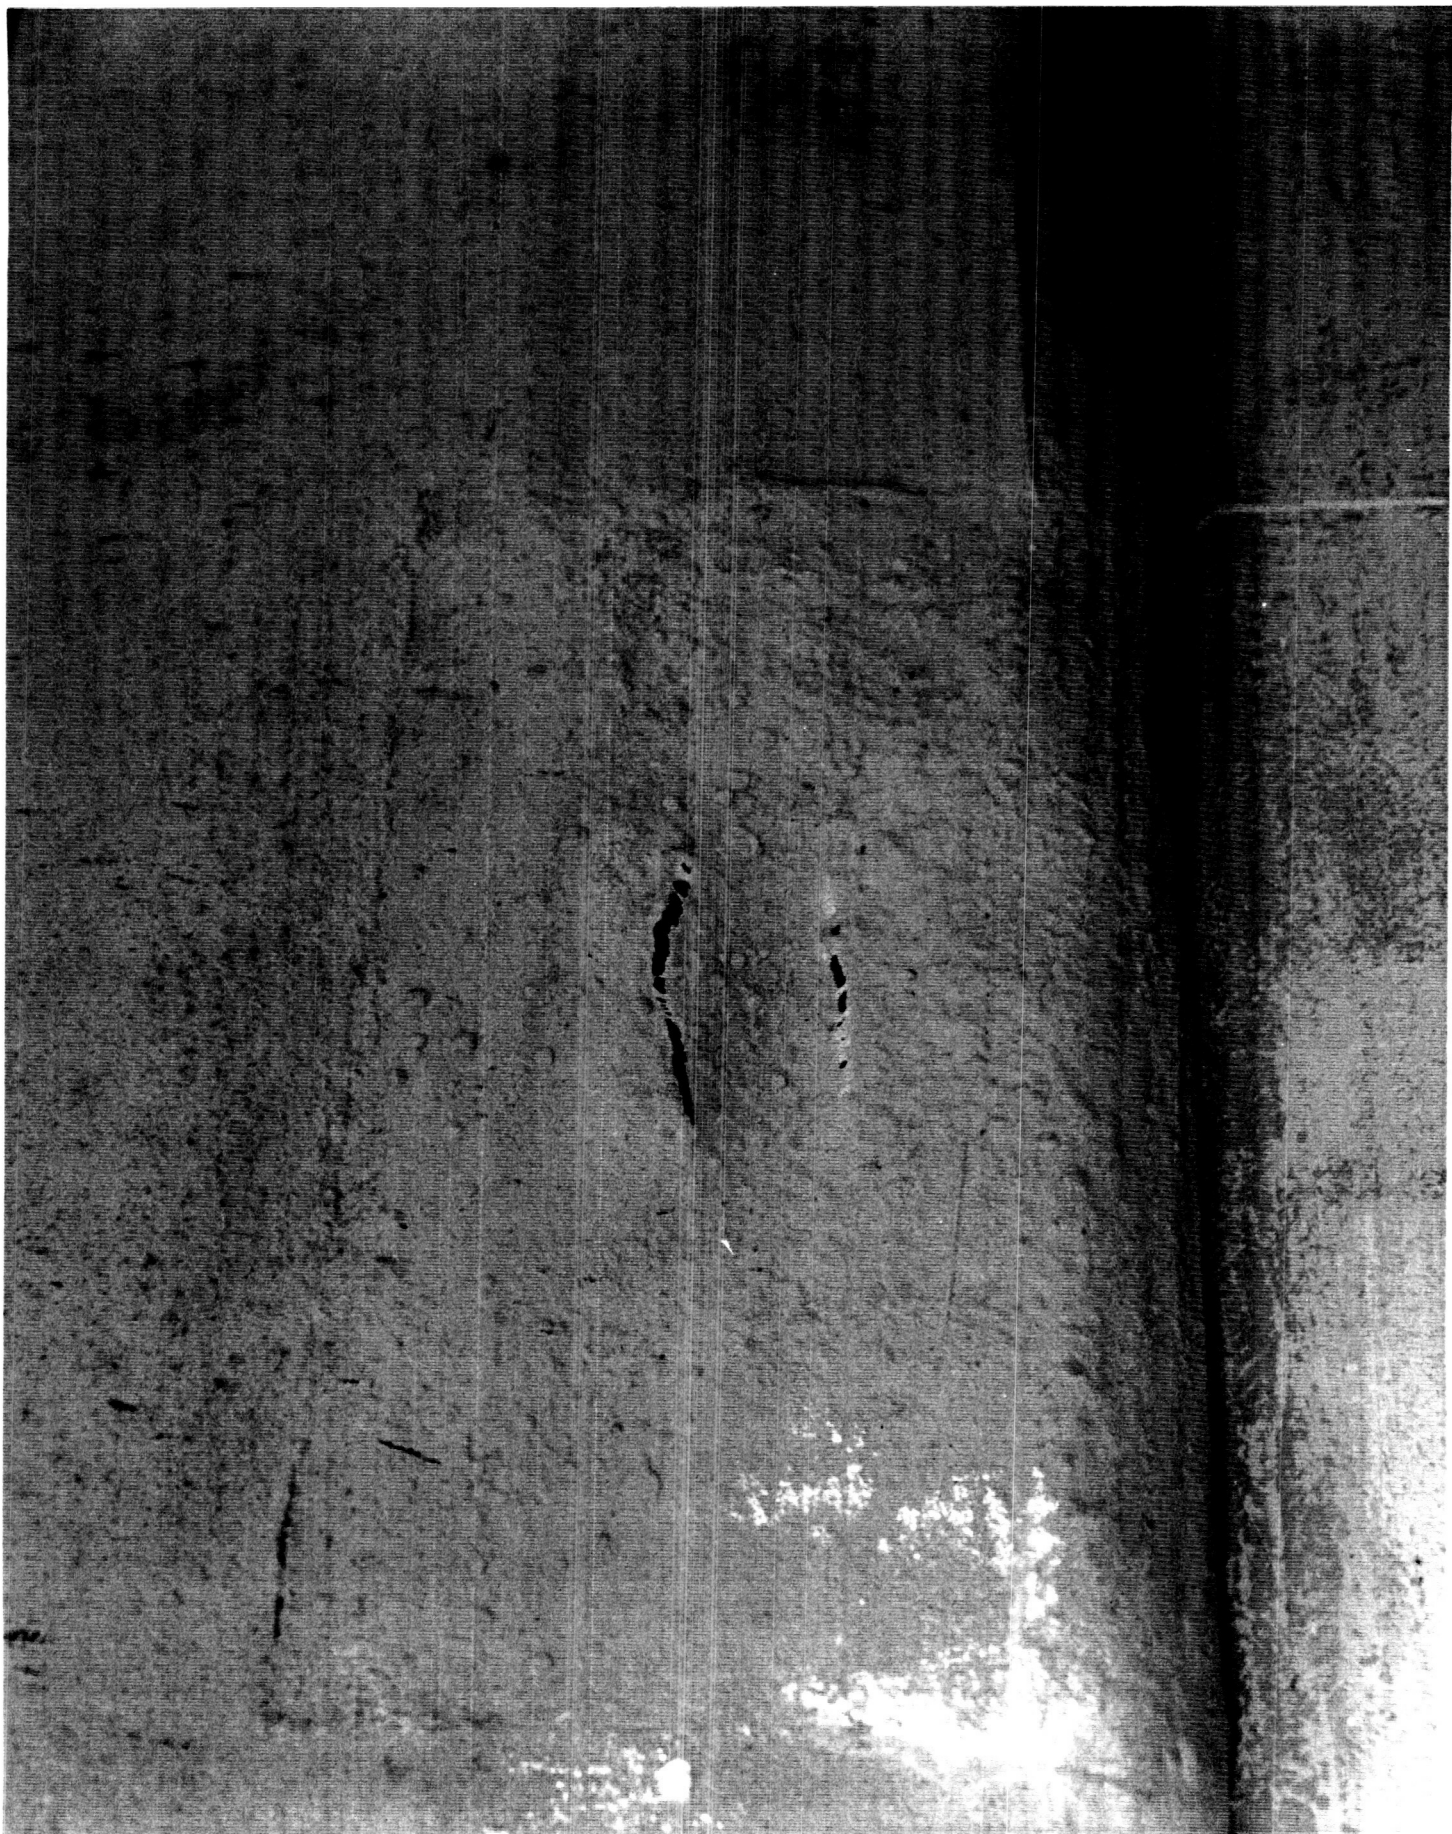
The aft field joint exhibited two cracks at the 45 degrees radial position where the trunnion had been potted in with K5NA. The 2-inch long cracks were parallel 1.25 inches apart and the material between the cracks could be depressed by moderate hand pressure. The trailing edge of the aft segment factory joint EPDM moisture seal showed discontinuous debonds around the entire circumference and measured 2.5 inches deep in some places. Trailing edge damage to the GEI cork runs was attributed to debris hits from the nozzle extension severance.

Two cracks appeared in the LH aft field joint closeout
where the trunnion had been potted in with K5NA

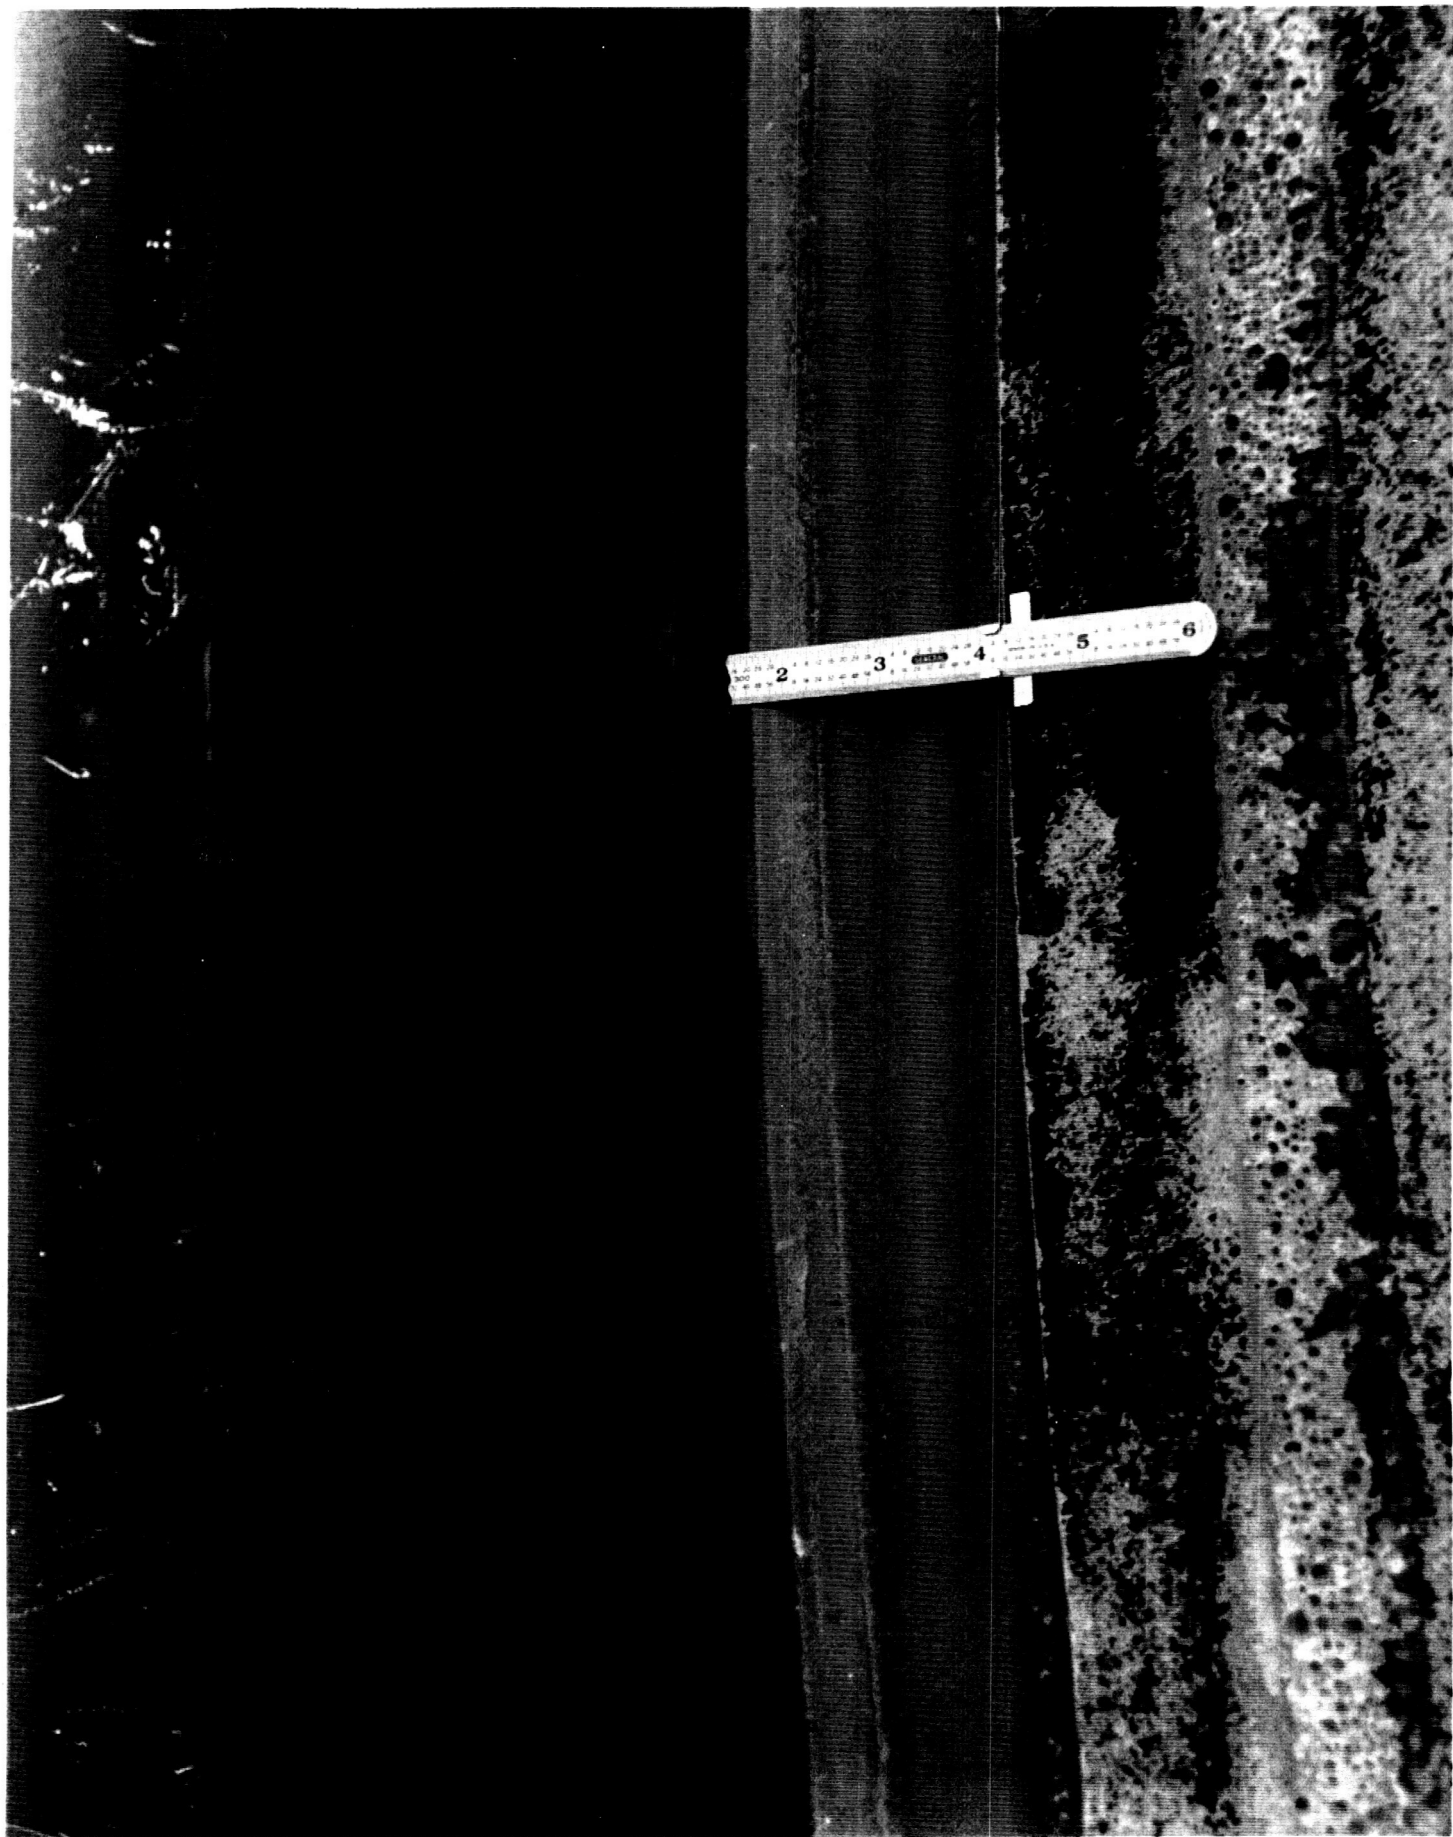
The trailing edge of the LH aft segment factory joint EPDM moisture seal showed debonds around the entire circumference

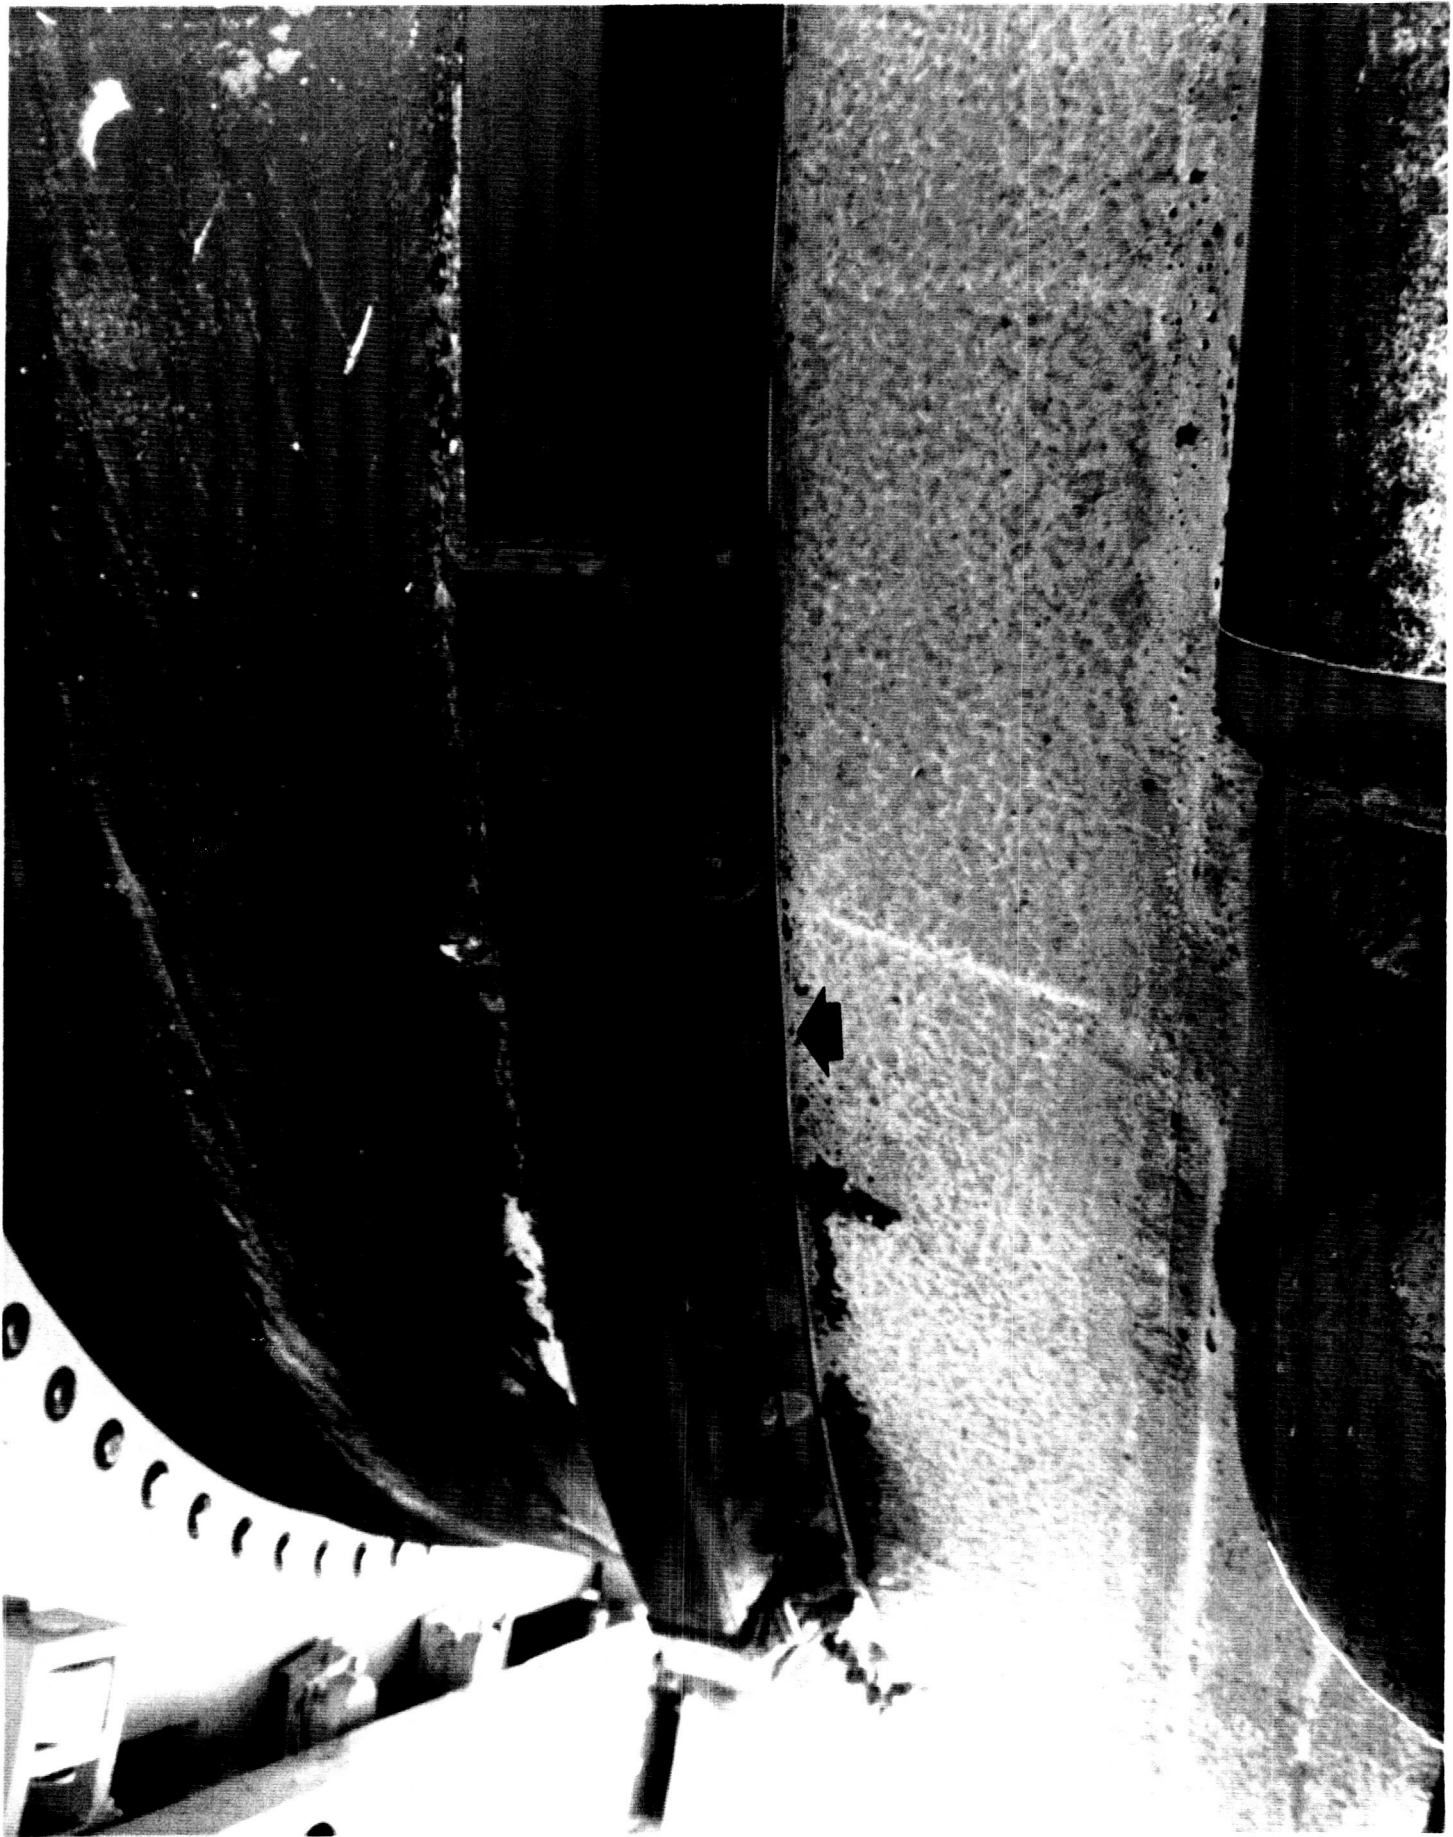
K5NA thermal protective domes were missing from bolt heads on the aft side of the kick ring. Uncovered substrate was sooted.

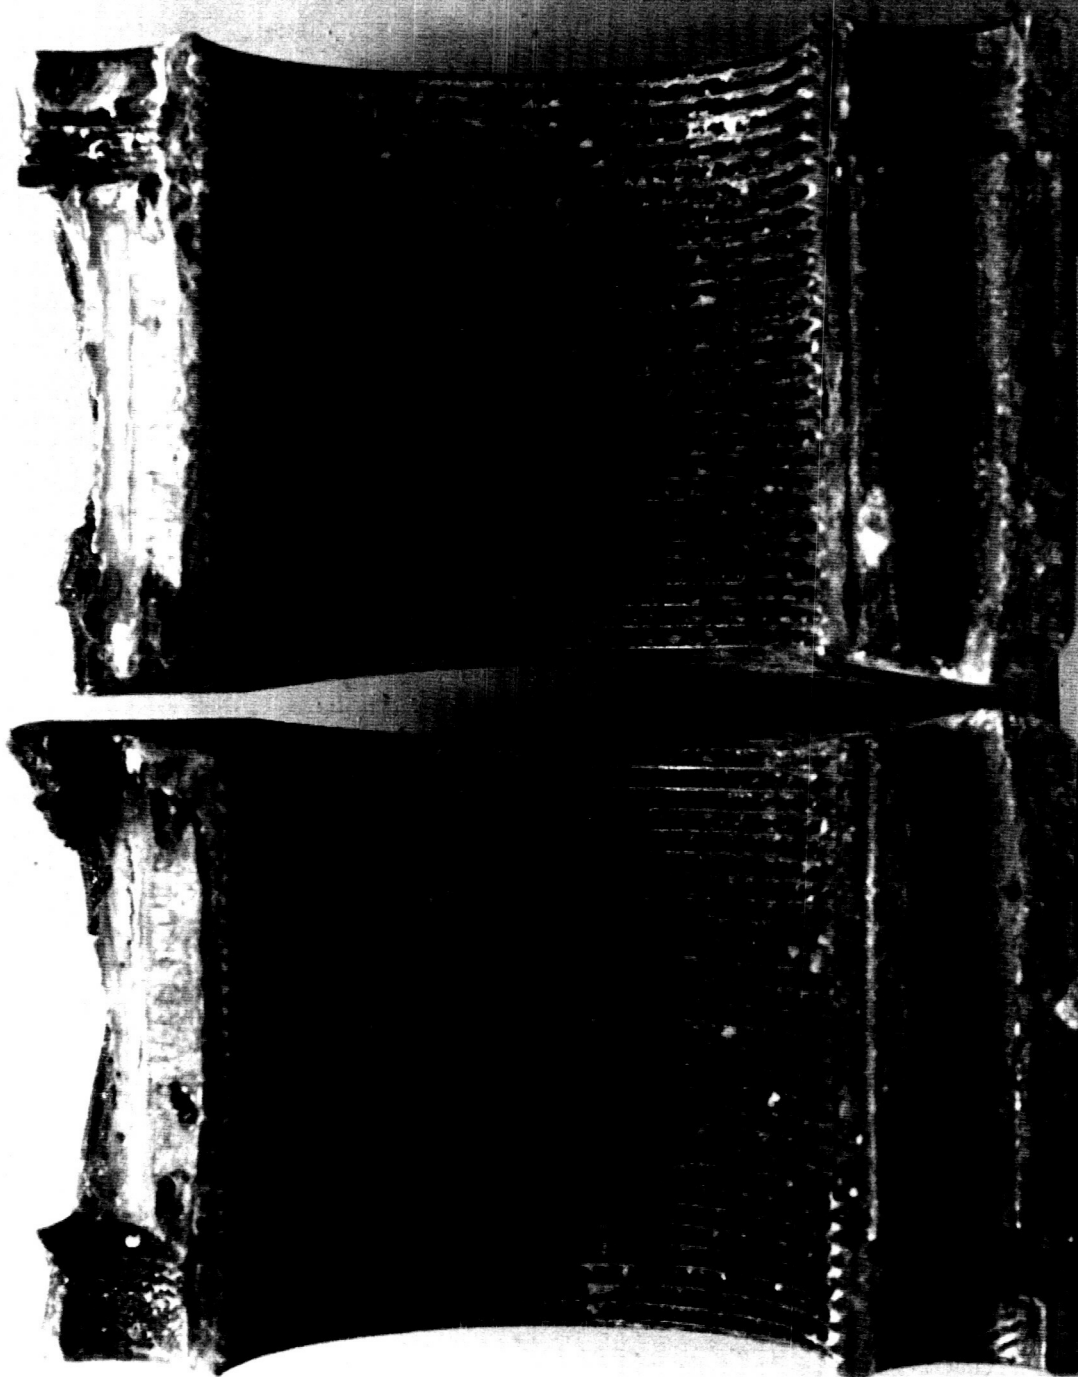
Lab inspection of HDP #3 frangible nut shows tensile failure of the material and indicates non-simultaneous firing of ordnance

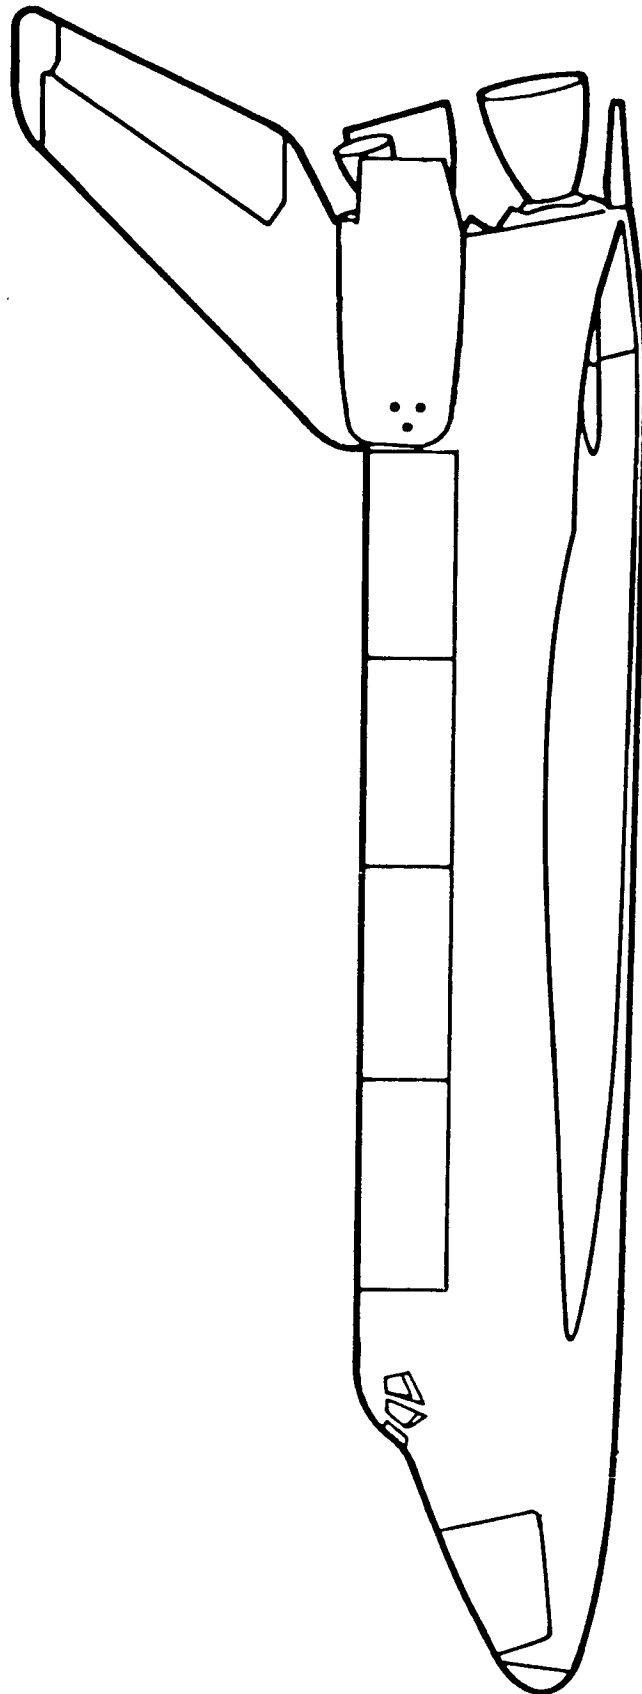
FIGURE 15. DEBRIS DAMAGE LOCATION

TOTAL HITS = 3
HITS \geq 1 INCH = 0

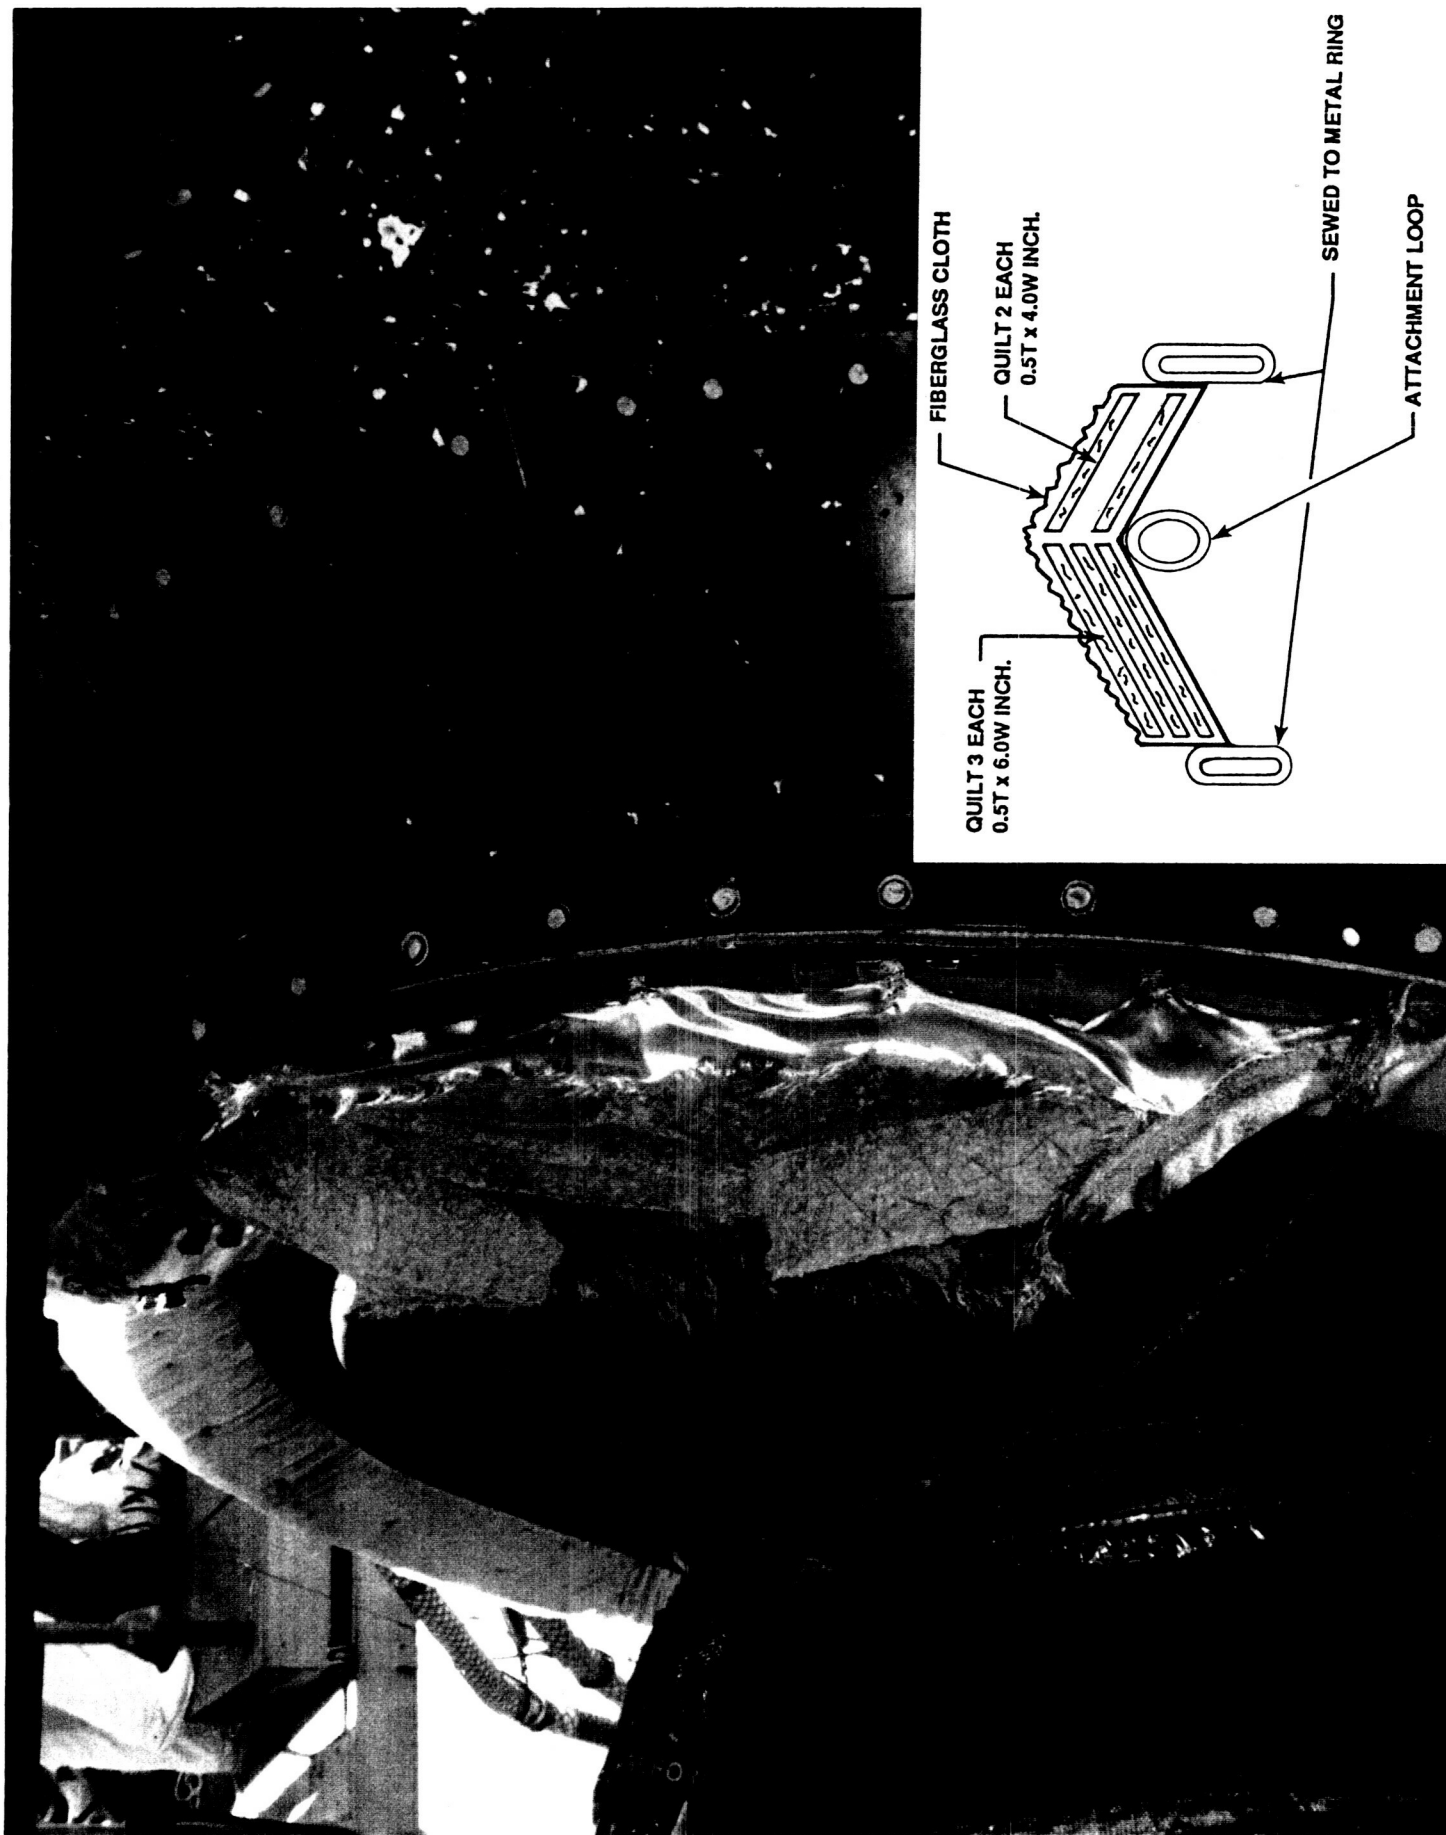
SSME engine-mounted heat shield closeout blankets
were torn and frayed
